**Maine Terrestrial Wildlife Crossings Survey Report:**  
***Potential for Retrofitting Transportation Infrastructure to  
Benefit Movement of Terrestrial Wildlife***

**July 2015**

**In Collaboration with:**  
**Maine Department of Transportation, Richard Bostwick**  
**Maine Inland Fisheries & Wildlife, Derek Yorks**  
**The Nature Conservancy, Dan Coker**

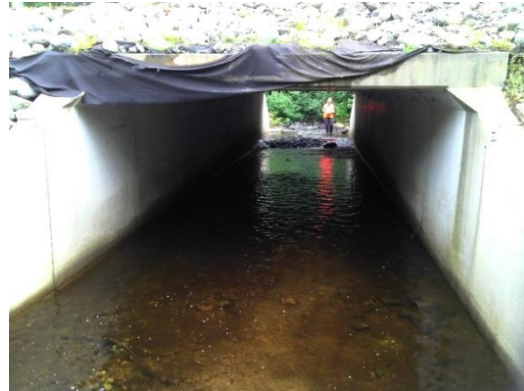
No stream bank through structure on Route 27,  
Carrabassett Valley © Maine Audubon

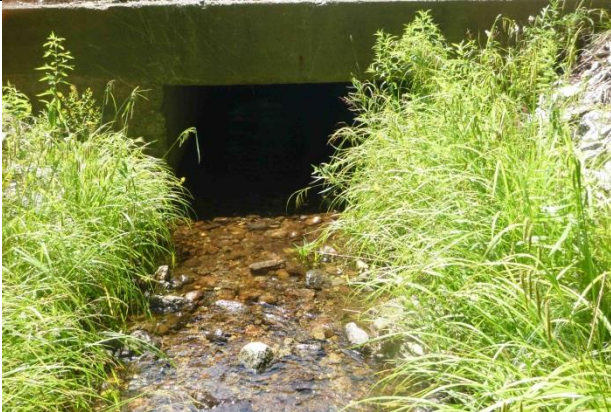
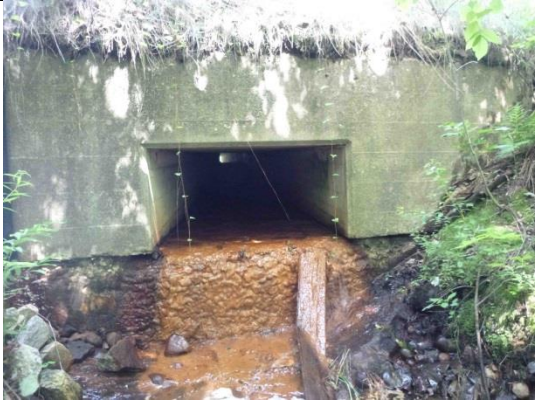
RETROFIT PRIORITIES: Bethel-Greenwood-Woodstock, Route 26	
<b>Gree-1</b>	<ul style="list-style-type: none"><li>• Small box culvert (5-8' wide by 2-5' high by &lt;65' long).</li><li>• Perennial stream with low water depth (&lt;3"), stony streambed through structure. Lacks dry pathway.</li><li>• Large culvert drop at outlet (&gt;2' high).</li></ul>
<b>Retrofit Recommendation</b>	<ul style="list-style-type: none"><li>• Retrofitting would require providing access at outlet side by removing drop and restoring stream grade.</li><li>• Install shelf along one side of culvert connecting into adjacent habitat to facilitate passage by species that require dry, level pathway.</li><li>• Install wildlife fencing to guide animals towards bridge.</li></ul>

<i>Photo 9. Gree-1: Natural grade, stony streambed at inlet.</i>	<i>Photo 10. Gree-1: Outlet drop.</i>

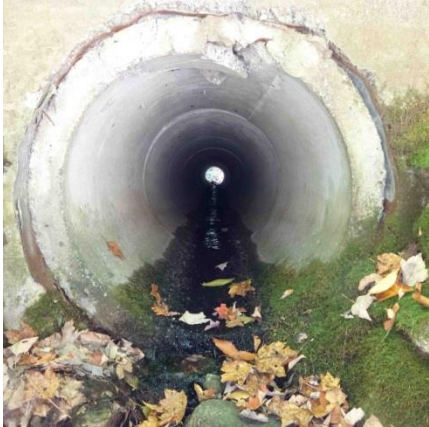
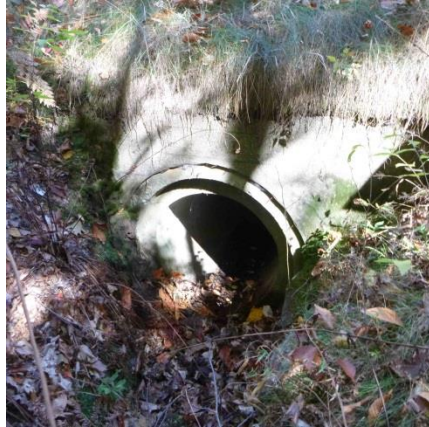
<b>Woodstock-6</b>	<ul style="list-style-type: none"> <li>• Concrete pipe culvert (2 to &lt;5' diameter by &lt;65' long) with intermittent water flows (low flow at time of survey).</li> <li>• Perched outlet (12" high).</li> <li>• Forest habitat.</li> </ul>
Retrofit Recommendation	<ul style="list-style-type: none"> <li>• Grade outlet perch to improve wildlife access into culvert.</li> <li>• Remove woody debris blocking access to inlet.</li> <li>• Install small animal fencing to guide wildlife towards culvert.</li> </ul>

<i>Photo 11. Woodstock-6: Intermittent water flow through pipe. Perched outlet.</i>	<i>Photo 12. Woodstock-6: Inlet located at base of fill slope.</i>
<b>Wood-8</b>	<ul style="list-style-type: none"> <li>• Small, long and dark culvert with perennial, low water flows; large concrete headwall and pooling at inlet.</li> <li>• Extensive sediment deposition at outlet (reduces effective culvert height at outlet); water pools downstream from outlet.</li> <li>• Forested, wetland habitat with adjacent residential development.</li> </ul>

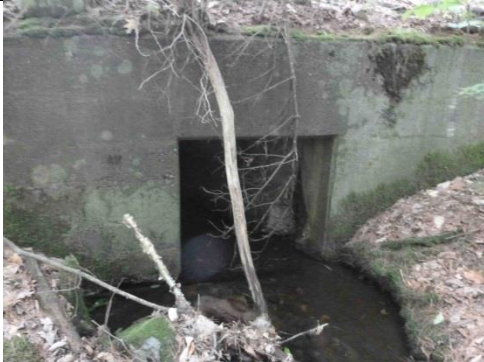
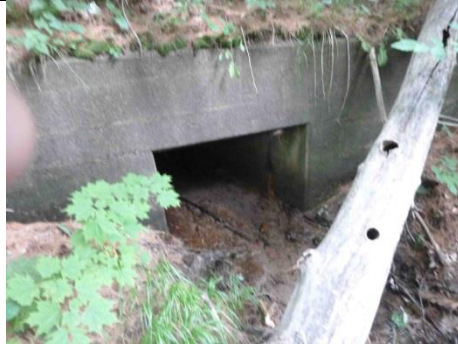
<i>Photo 13. Wood-8: Pooling at inlet.</i>	<i>Photo 14. Wood-8: Sediment deposition at outlet.</i>

Retrofit Recommendation	<ul style="list-style-type: none"> <li>• Remove sediment from culvert (leaving a small layer of sediment over concrete bottom) and implement sediment controls to prevent further sediment deposition.</li> <li>• Install small animal fencing to guide wildlife to culvert.</li> </ul>

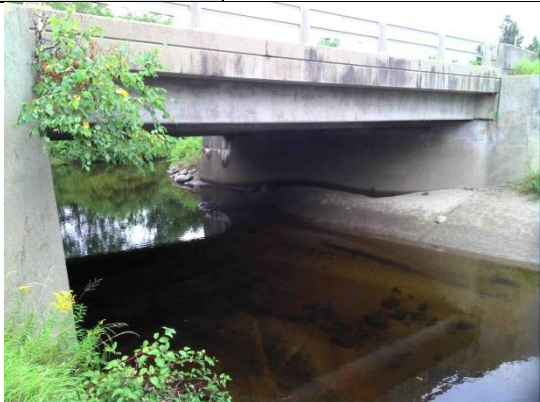
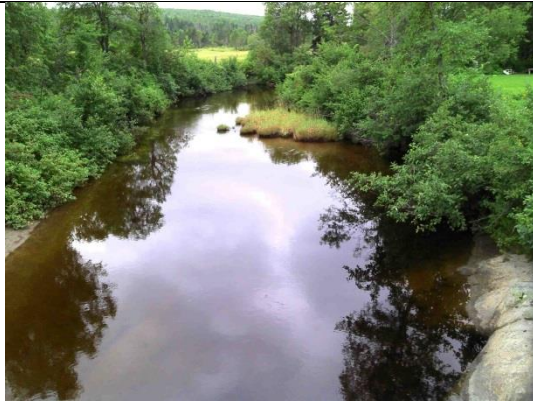
RETROFIT PRIORITIES: Carrabassett Valley Route 27	
<b>CARRA-3</b>	Bridge with concrete vertical abutments over Stratton Brook. Discontinuous dry pathway along south side of structure under low flow conditions. May offer limited functionality for some Large-Structure Generalists willing to get wet feet.
Retrofit Recommendation	Investigate whether it would be possible to build up soil so that there is a continuous dry pathway during low flows. Install a shelf along the south side of the bridge to facilitate passage for Medium-Structure Generalists. Install wildlife fencing to guide animals towards bridge.

<i>Photo 29. CARRA-3: Water flow under bridge during low flows. Note partial dry pathway.</i>	<i>Photo 30. CARRA-3: Upstream riparian habitat.</i>

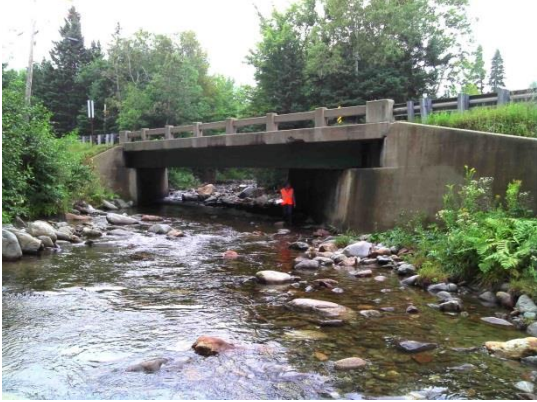
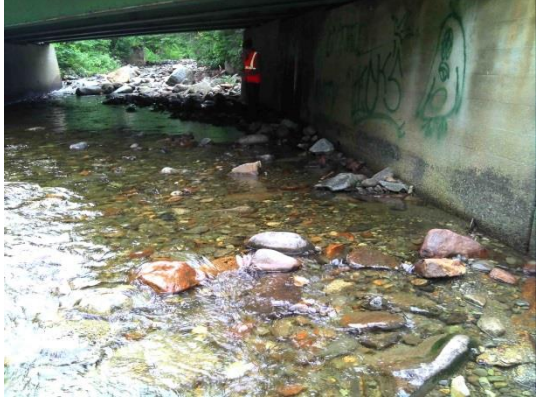
<b>CARRA-6</b>	<ul style="list-style-type: none"> <li>• Bridge over Stoney Brook (<math>\geq 40'</math> wide by 12 to <math>&lt; 20'</math> high by <math>&lt; 65'</math> long).</li> <li>• Rocky streambed may be difficult to traverse for some species. Dry pathway likely obliterated during high water events.</li> </ul>
Retrofit Recommendation	<ul style="list-style-type: none"> <li>• Create raised pathway through length of structure to facilitate passage by species that require dry, level pathway.</li> <li>• Install wildlife fencing to guide animals towards bridge.</li> <li>• Undersized structure unsuitable for Cover Obligates until replaced with larger span bridge and riparian banks restored.</li> </ul>

<i>Photo 31. CARRA-6: Rocky stream substrate through entire width and length of structure.</i>	<i>Photo 32. CARRA-6: Shallower water depth on inside bend of stream, but lacks dry, level pathway.</i>

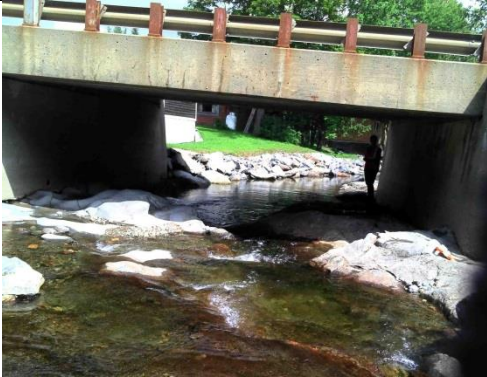
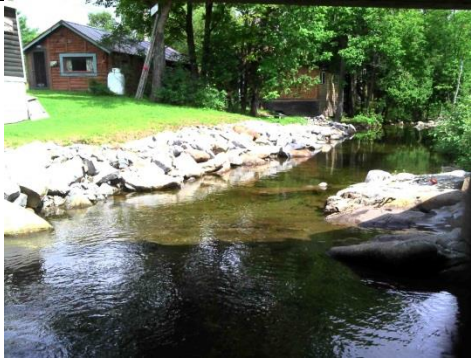
<b>CARRA-7</b>	<ul style="list-style-type: none"> <li>• Bridge spanning perennial stream (20 to <math>&lt; 40'</math> wide by 5 to <math>&lt; 8'</math> high by <math>&lt; 65'</math> long).</li> <li>• Streambed is very rocky and in places, exposed bedrock with deep channel incisions; the structure is not wide enough to span stream banks so there is no dry, level pathway.</li> </ul>
Retrofit Recommendation	<ul style="list-style-type: none"> <li>• Create raised pathway or install a shelf through length of structure to facilitate passage by species that require dry, level pathway.</li> <li>• Could be enhanced with guide fencing.</li> <li>• Undersized structure unsuitable for Cover Obligates until replaced with larger span bridge and riparian banks restored.</li> </ul>

<i>Photo 33. CARRA-7: Rocky, boulder streambed with no dry, level pathway through structure.</i>	<i>Photo 34. CARRA-7: Riprap banks and adjacent residences on outlet side.</i>

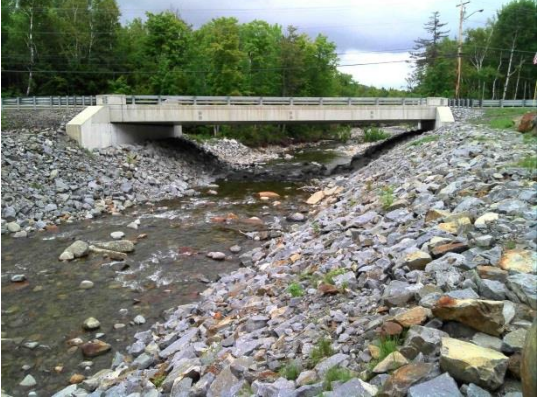
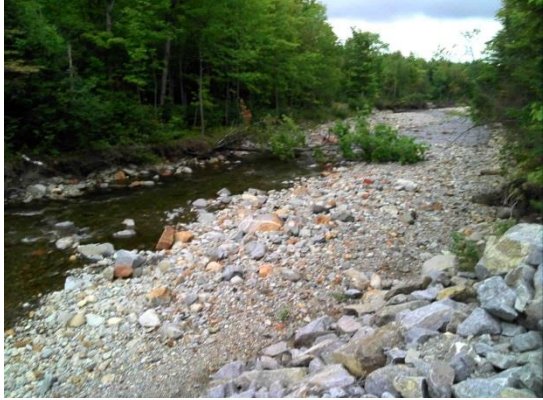
<b>CARRA-8</b>	<ul style="list-style-type: none"> <li>Bridge (<math>\geq 40'</math> wide by <math>\geq 20'</math> high by <math>&gt; 65'</math> long) with sloped riprap abutments and extensive riprap slopes on both sides of the bridge extending <math>\sim 100'</math> up- and downstream.</li> </ul>
Retrofit Recommendation	<ul style="list-style-type: none"> <li>Create pathways through riprap on both sides of stream.</li> <li>Install wildlife fencing to guide animals towards bridge entrances.</li> </ul>

<i>Photo 35. CARRA-8: Extensive riprap slopes on upstream side and through structure.</i>	<i>Photo 36. CARRA-8: Downstream view of rocky streambed and adjacent forest habitat.</i>
<b>CARRA-9</b>	<ul style="list-style-type: none"> <li>Bridge (<math>\geq 40'</math> wide by 12 to <math>&lt; 20'</math> high by <math>&gt; 65'</math> long) with riprap abutments.</li> <li>Parallel pedestrian bridge on upstream side.</li> <li>Currently functional for Semi-Aquatic Obligates and adaptive fauna that are willing to walk through shallow water or navigate across the riprap slopes.</li> </ul>

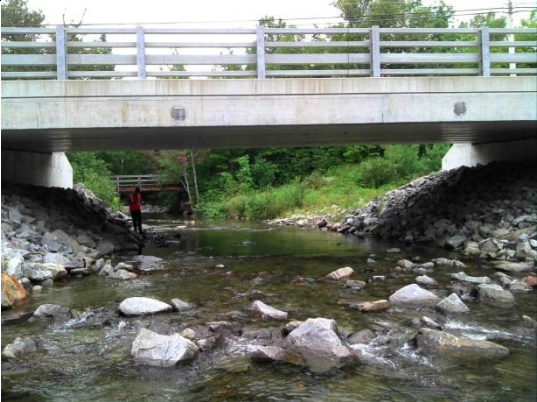
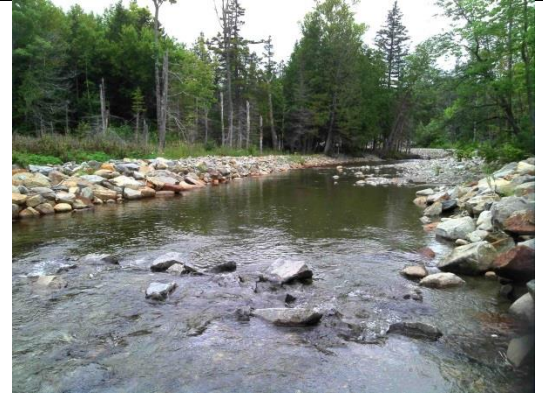
<i>Photo 37. CARRA-9: Rocky stream and riprap bridge abutments.</i>	<i>Photo 38. CARRA-9: Downstream view of rocky streambed and adjacent forest habitat.</i>

Retrofit Recommendation	<ul style="list-style-type: none"> <li>Create pathways through riprap on both sides of stream.</li> <li>Install wildlife fencing to guide animals towards bridge entrances.</li> </ul>

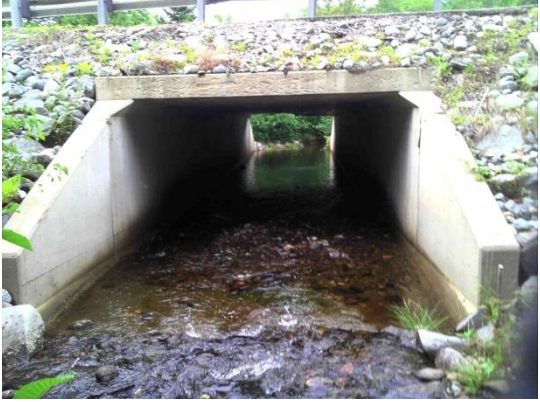
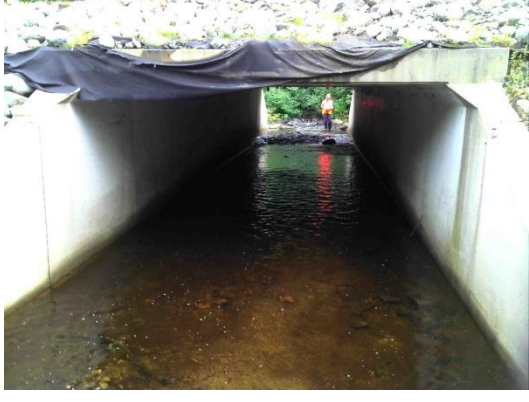
<b>CARRA-10</b>	<ul style="list-style-type: none"> <li>Concrete box culvert (8 to &lt;20' wide by 5 to &lt;8' high by 65 to 100' long). Culvert is slightly wider than stream channel causing flow to spread out through culvert. Water depth at time of assessment was &lt;3' deep. Sand, gravel and woody debris deposits inside culvert.</li> </ul>
Retrofit Recommendation	<ul style="list-style-type: none"> <li>Install a culvert shelf connecting to adjacent habitat to provide dry, level pathway.</li> <li>Install wildlife fencing to guide animals towards culvert entrances.</li> </ul>

Photo 39. CARRA-10: Culvert inlet.	Photo 40. CARRA-10: Altered stream geomorphology through culvert.

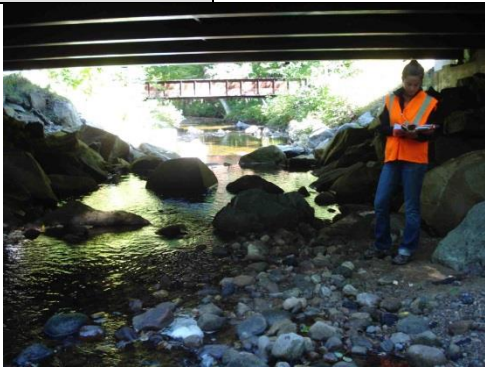
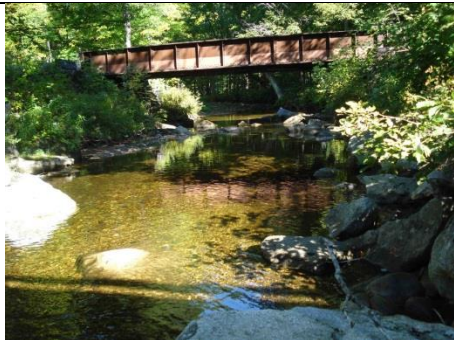
Photo 16. Bethel-2: Riprap banks.	Photo 17. Bethel-2: Parallel railroad bridge.
<b>BETHEL-3</b>	<ul style="list-style-type: none"> <li>• Large, high Bridge spanning perennial stream; Riprap abutments and rocky streambed.</li> <li>• Abundant wildlife tracks in and around structure (deer, fox, moose, raccoon, weasel).</li> </ul>

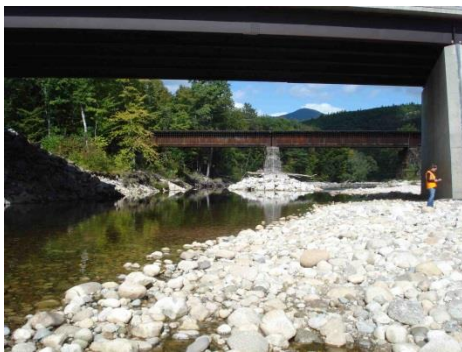
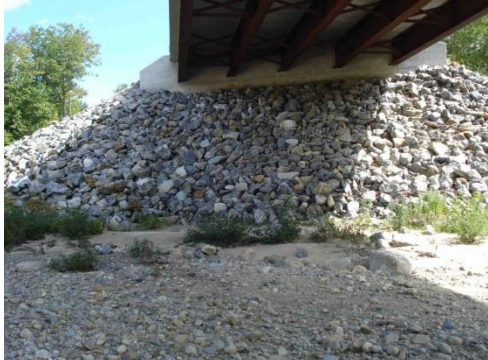
Photo 18. Bethel-3: Stream bed beneath span and adjacent railroad bridge.	Photo 19. Bethel-3: Sandy, dry pathway at base of riprap abutments.

Retrofit Recommendation	<ul style="list-style-type: none"> <li>• Add a dry level pathway through the riprap slope on the west side of stream.</li> <li>• Install wildlife fencing to guide animals towards bridge entrances.</li> </ul>

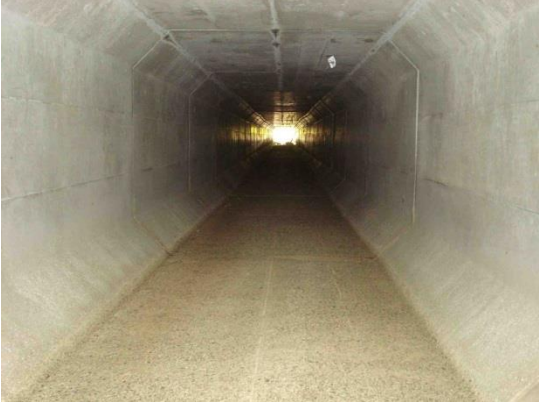
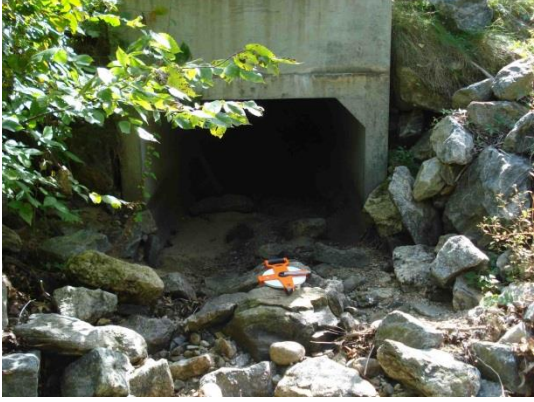
<b>BETHEL-5</b>	<ul style="list-style-type: none"> <li>• Medium-sized, long concrete box culvert (5' to 8' wide by 2' to 5' high by 100' to &lt;150' long).</li> <li>• Appears culvert is dry much of the year, investigate hydrology.</li> <li>• Signs of small and medium-sized mammals observed, including possible fox, fisher, and marten tracks.</li> <li>• Second stone box culvert downstream at railroad crossing.</li> </ul>
Retrofit Recommendation	<ul style="list-style-type: none"> <li>• Install sediment-catching baffles.</li> <li>• Install wildlife fencing to guide animals towards culvert entrances.</li> </ul>

<i>Photo 20. Bethel-5: View through concrete box culvert in dry conditions.</i>	<i>Photo 21. Bethel-5: Rocky culvert inlet.</i>
<b>BETHEL-8</b>	<ul style="list-style-type: none"> <li>• Concrete dry 4-sided box culvert (5 to &lt;8' wide by 5 to &lt;8' high); likely seasonal storm flows through structure.</li> </ul>

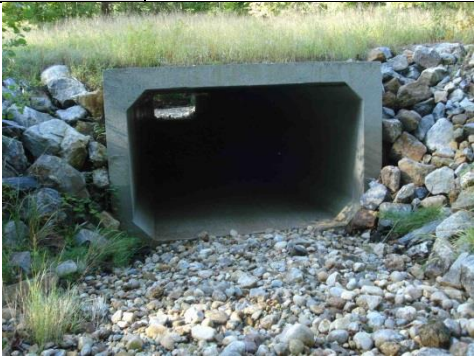
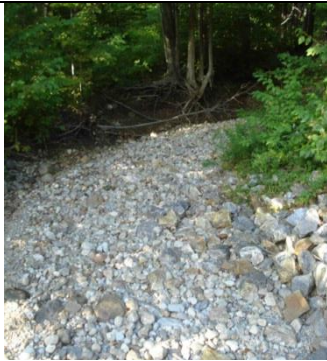
<i>Photo 22. Bethel-8: Rocky approach to culvert inlet, with concrete substrate through structure.</i>	<i>Photo 23. Bethel-8: From outlet looking downstream.</i>

Retrofit Recommendation	<ul style="list-style-type: none"> <li>• Enhance approaches to provide pathway through rocks.</li> <li>• Investigate whether it would be hydrologically acceptable to add cover elements along one side of structure (e.g., down logs and woody debris).</li> <li>• Install wildlife fencing to guide animals towards culvert entrances.</li> </ul>

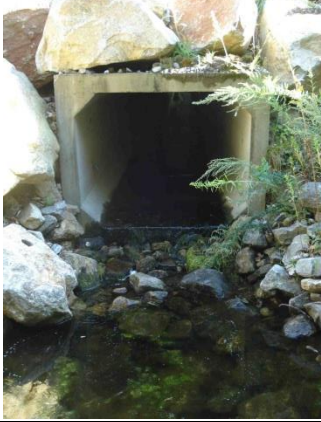
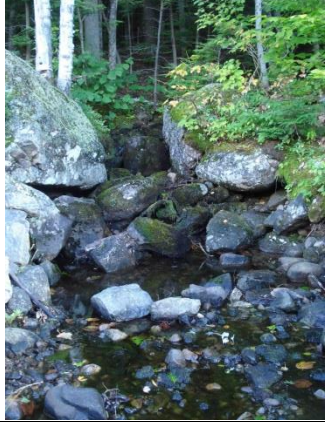
<b>BETHEL-9</b>	<ul style="list-style-type: none"> <li>Concrete box culvert (5 to 8' wide by 2 to 5' high by &lt;65' long) with small perennial stream (low depth); no dry pathway.</li> <li>Perched outlet, shallow pooling.</li> <li>Rocky streambed, riprap surrounding culvert.</li> </ul>
Retrofit Recommendation	<ul style="list-style-type: none"> <li>Create a level pathway through riprap to provide better access into both ends of culvert.</li> <li>Investigate opportunity for installing a dry shelf or ledge through culvert and connecting into adjacent habitat.</li> <li>Install wildlife fencing to guide animals towards culvert entrances.</li> </ul>

<i>Photo 24. Bethel-9: Outlet perch, rocky streambed and adjacent riprap.</i>	<i>Photo 25. Bethel-9: Rocky streambed and boulders at Inlet.</i>
<b>BETHEL-10</b>	<ul style="list-style-type: none"> <li>Bridge (&gt;40' wide by &gt;20' high by &lt;65' long) with riprap abutments; No level pathway present through structure.</li> </ul>

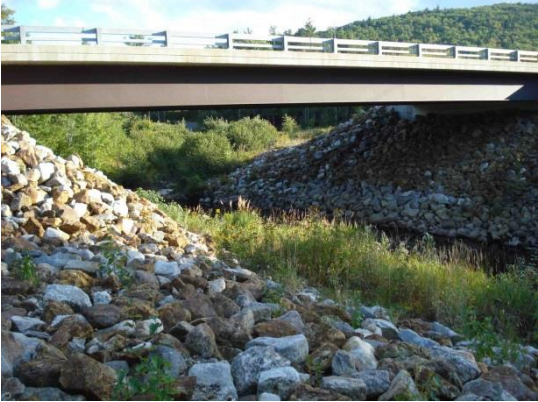
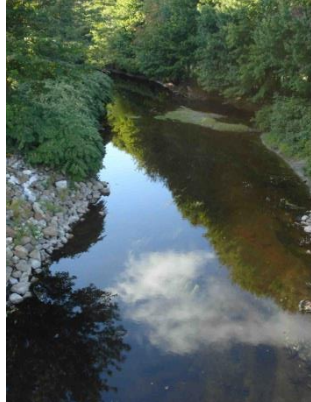
<i>Photo 26. Bethel-10: Riprap abutments to water's edge on both sides of stream</i>	<i>Photo 27. Bethel-10: Downstream view.</i>

Retrofit Recommendation	<ul style="list-style-type: none"> <li>Create pathways through riprap on both sides of stream.</li> <li>Install wildlife fencing to guide animals towards bridge approaches.</li> </ul>

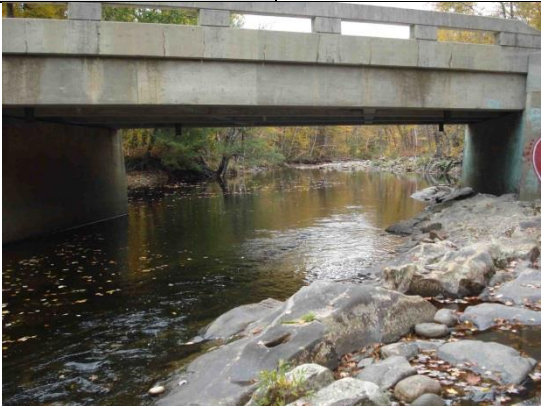
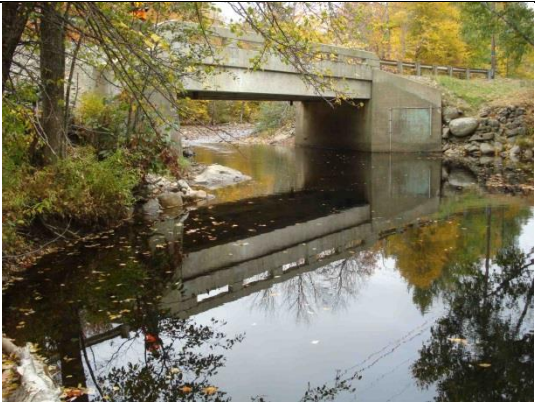
RETROFIT PRIORITIES: Madrid Route 4	
<b>Madrid-3</b>	<ul style="list-style-type: none"> <li>• Bridge with vertical, concrete abutments (44' wide by 9' high by &lt;65' long).</li> <li>• Perennial stream &gt;3' deep during average flows; Dry bedrock pathway along one side of structure during average flows.</li> <li>• Undersized structure does not span riparian banks; wide pool at outlet.</li> <li>• Functional only for fauna willing to walk or swim through deep water.</li> </ul>
<b>Retrofit Recommendation</b>	<ul style="list-style-type: none"> <li>• Install shelf through bridge on the side opposite the bedrock pathway, connecting into adjacent habitat on either side of bridge.</li> <li>• Install wildlife fencing to guide animals towards bridge.</li> <li>• Ideally, replace structure with a wider span and restore natural riparian banks.</li> </ul>

<i>Photo 47.</i> Madrid-3: Bedrock pathway through structure does not connect to habitat on outlet side.	<i>Photo 48.</i> Madrid-3: Pooling at outlet blocks pathway connection to adjacent habitat.

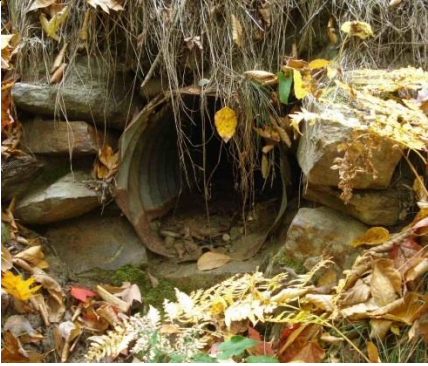
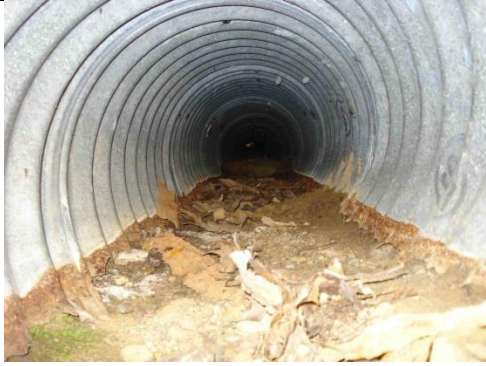
<b>Madrid-4</b>	<ul style="list-style-type: none"> <li>• Small, metal pipe (&lt;2' diameter by &lt;65' long) with soil/leaf litter substrate through culvert. No water flow, though storm flows are likely.</li> <li>• Likely has functionality for Cover Obligates, including small mammals and salamanders, and possibly, frogs.</li> </ul>
Retrofit Recommendation	<ul style="list-style-type: none"> <li>• Install limited small and medium-sized wildlife fencing to guide animals towards culvert entrances.</li> </ul>

<i>Photo 49. Madrid-4: Vegetation and leaf litter at culvert outlet</i>	<i>Photo 50. Madrid-4: Sediment pathway through culvert with leaf litter.</i>
<b>Madrid-7</b>	<ul style="list-style-type: none"> <li>• Concrete box culvert (2' to &lt;5' wide by 2' to &lt;5' high by &lt;65' long with perennial stream and no dry, terrestrial pathway. Perched outlet (4" high).</li> <li>• Instream grade drop immediately in front of culvert inlet may limit some wildlife access into culvert.</li> <li>• Some debris blockage inside culvert.</li> </ul>

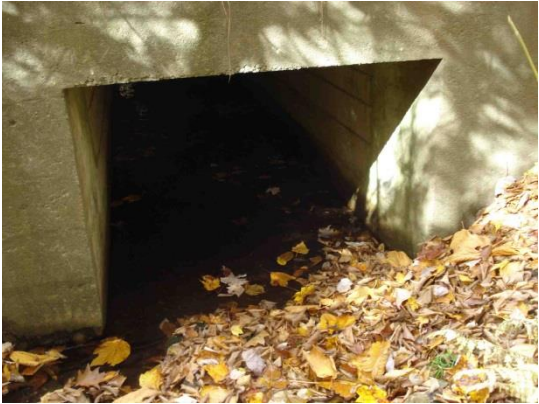
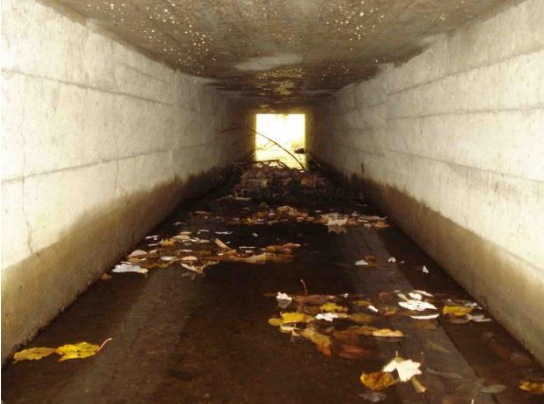
<i>Photo 51. Madrid-7: Culvert inlet with partial view of grade drop immediately in front of entrance.</i>	<i>Photo 52. Madrid-7: Change in stream geomorphology through culvert. No dry pathway available.</i>

Retrofit Recommendation	<ul style="list-style-type: none"> <li>• Install shelf through culvert connecting into adjacent habitat.</li> <li>• Remove debris inside culvert.</li> <li>• Install wildlife fencing to guide animals to culvert.</li> </ul>

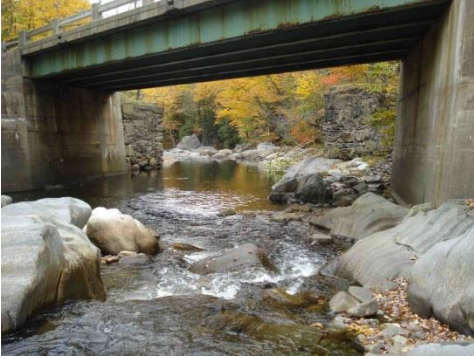
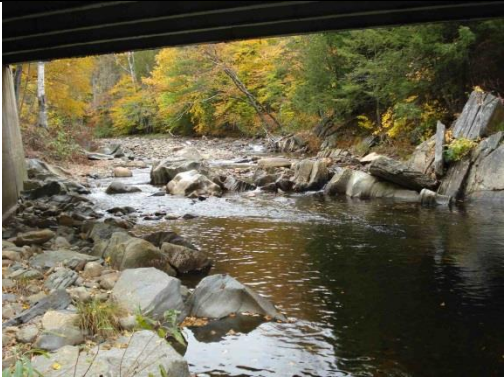
<b>Madrid-13</b>	<ul style="list-style-type: none"> <li>• Bridge with vertical, concrete abutments (<math>\geq 40'</math> wide by 12 to <math>&lt; 20'</math> high by <math>&lt; 65'</math> long).</li> <li>• Perennial stream <math>&gt; 3'</math> deep during average flows; Dry, boulder/rock pathway along one side of structure during average flows.</li> <li>• Functional only for fauna willing to traverse rocky pathway or walk/swim through deep water. Adjacent old stone abutments from bridge may block wildlife access to bridge.</li> <li>• Stony river corridor with adjacent forest habitat.</li> </ul>
Retrofit Recommendation	<ul style="list-style-type: none"> <li>• Remove old stone abutments to enhance wildlife access to Bridge.</li> <li>• Install shelf through bridge on the side opposite the rocky pathway, connecting into adjacent habitat on either side of bridge.</li> <li>• Install wildlife fencing to guide animals to bridge.</li> <li>• Ideally, replace structure with a wider span and restore natural riparian banks to provide natural cover.</li> </ul>

<p><i>Photo 53. Madrid-13: View downstream. Note how old abutments from prior bridge adjacent to current bridge reduce access to bridge and effectively lengthen the distance terrestrial wildlife must travel to access adjacent habitat.</i></p>	<p><i>Photo 54. Madrid-13: View upstream, with dry, rocky pathway along one side of bridge (note pathway composed of boulder on downstream side, outside of the view of this image).</i></p>

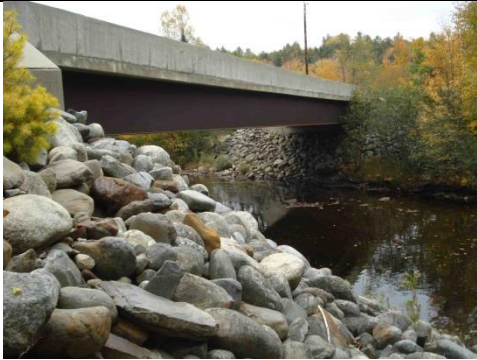
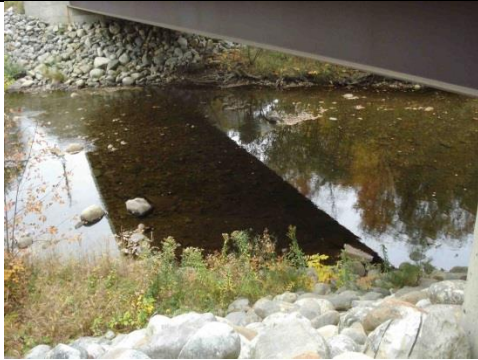
<b>Madrid-14</b>	<ul style="list-style-type: none"> <li>• Bridge spanning river &lt;3' deep.</li> <li>• Steep, rocky abutments on both sides of river; no dry, level pathways through structure.</li> <li>• Adjacent forest habitat.</li> </ul>
Retrofit Recommendation	<ul style="list-style-type: none"> <li>• Create natural substrate pathway across riprap to connect to adjacent habitat. The steepness of the slopes may require constructing a gabion wall (a cage filled with rocks, sand and soil) or other support structure.</li> <li>• Install wildlife fencing to guide animals to bridge.</li> <li>• Ideally, replace structure with a wider span and restore natural riparian banks to provide natural cover.</li> </ul>

<i>Photo 55. Madrid-14: Span bridge with steep, rocky abutments and adjacent forest cover.</i>	<i>Photo 56. Madrid-14: Span bridge with steep, rocky abutments.</i>
<b>Madrid-15</b>	<ul style="list-style-type: none"> <li>• Bridge spanning perennial stream &lt;3' deep.</li> <li>• Steep, rocky abutments on both sides of stream with a more gradual slope and less rocky area along stream banks where wildlife passage is more likely.</li> <li>• Natural riparian banks on either side of bridge; adjacent agricultural fields</li> </ul>

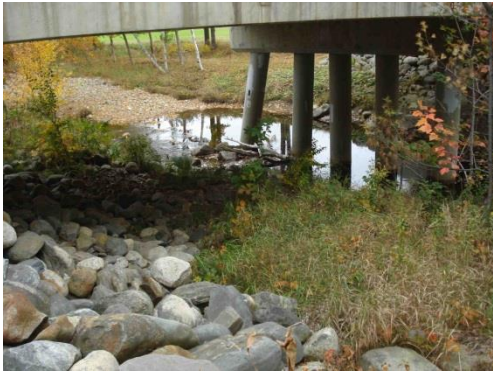
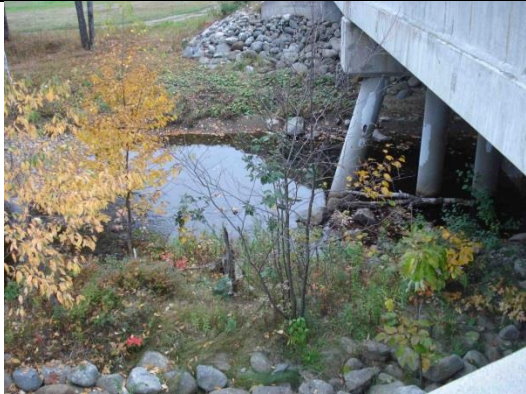
<i>Photo 57. Madrid-15: Span bridge over stream.</i>	<i>Photo 58. Madrid-15: Rocky abutments transition to more natural riparian banks.</i>

Retrofit Recommendation	<ul style="list-style-type: none"> <li>• Restore riparian banks through structure to provide a natural, non-rocky pathway and natural cover for Cover Obligates and Conditions Specialists.</li> <li>• Install wildlife fencing to guide animals to bridge.</li> </ul>

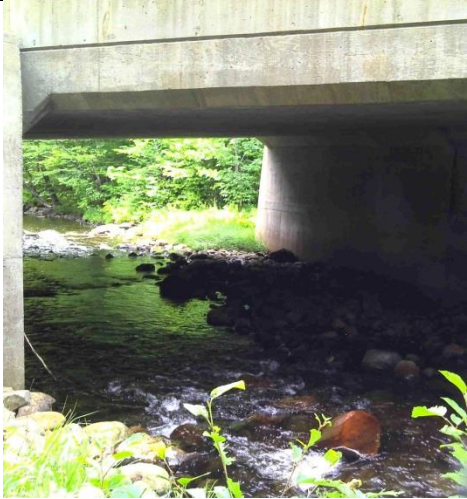
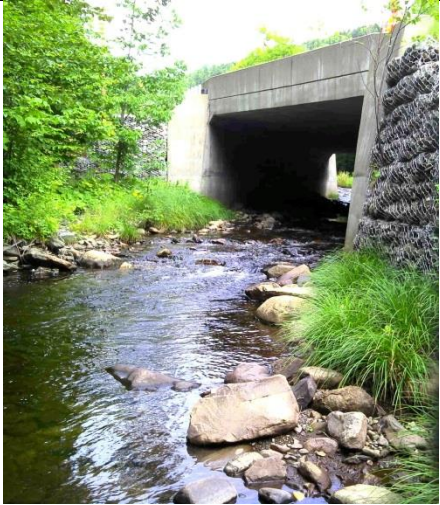
RETROFIT PRIORITIES: Sandy River PLT: Route 4	
<b>Sandy-2</b>	<ul style="list-style-type: none"><li>• Single span bridge over Sandy River (20' to &lt;40' wide by 12' to &lt;20' high by 65' to &lt;100' long).</li><li>• Concrete apron at inlet and rocky streambed may be difficult to traverse for some species.</li><li>• Rocky, dry pathway not continuous through structure and likely inundated during high water events.</li><li>• Gabion wing walls on both sides of structure.</li></ul>
Retrofit Recommendation	<ul style="list-style-type: none"><li>• Fully connect rocky pathway to adjacent habitat and supplement with soil substrate to create a level path.</li><li>• Investigate installing a raised shelf on the side opposite the pathway connecting to adjacent habitat.</li><li>• Install wildlife fencing to guide animals towards bridge.</li></ul>

<i>Photo 63.</i> Sandy-2: Rocky dry pathway along one side of bridge, but not does not fully connect to adjacent habitat.	<i>Photo 64.</i> Sandy-2: Outlet with gabion wing walls.

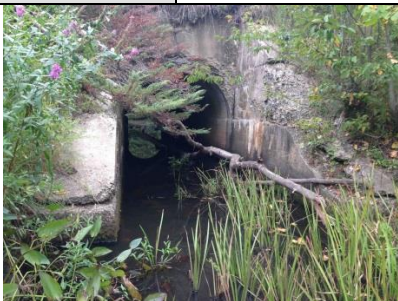
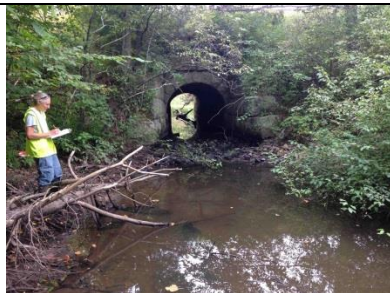
Photo 42. Eliot-1: Wetland vegetation at culvert inlet; Lack of dry pathway through structure.		Photo 43. Eliot-1: Pooling at outlet .

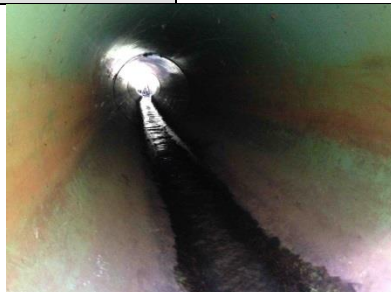
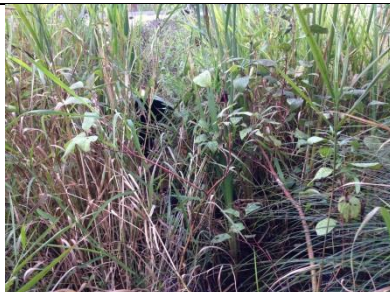
Photo 44. Eliot-5: Tunnel-like view through culvert.		Photo 45. Eliot-5: Thick vegetation cover at both culvert entrances.

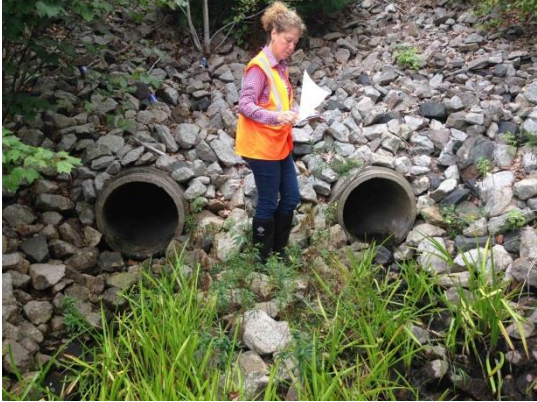
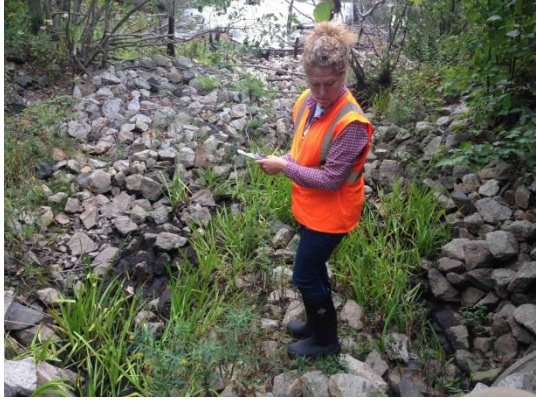
<i>Photo 2. Bell-1: Outlets with small rock cascade.</i>	<i>Photo 3. Bell-1: Extensive riprap at outlet; reservoir beyond.</i>

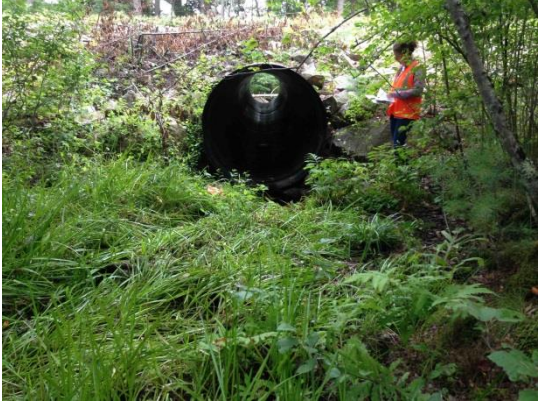
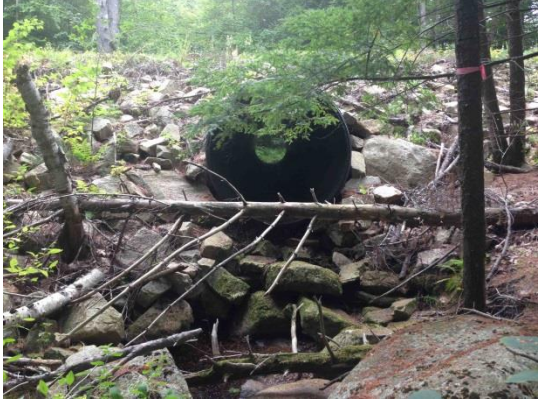
<i>Photo 4. Bell-8: Inlet side.</i>	<i>Photo 5. Bell-8: Perched outlet and riprap culvert approach.</i>
<b>BELL-10</b>	<ul style="list-style-type: none"> <li>• Single span bridge overpass (20' to 40' wide by 12' to 20' high by 25' long).</li> <li>• Shrubby wetland with beaver dam at inlet, but no pooling immediately in front of structure entrance. Forest cover at outlet.</li> <li>• Water flow through structure, with extensive riprap banks.</li> </ul>

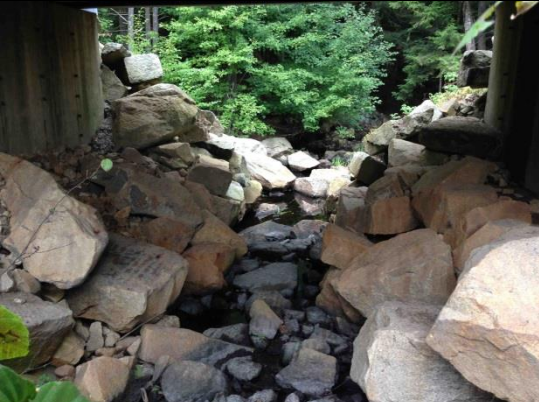
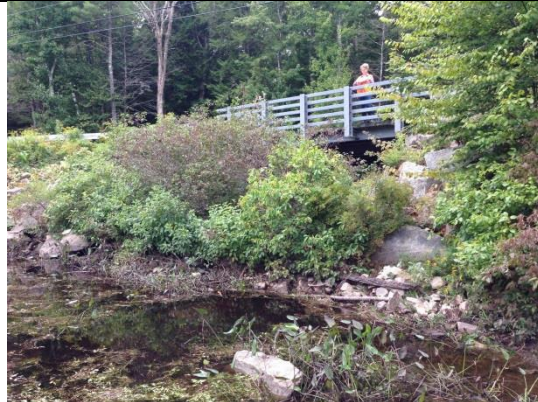
<i>Photo 6. Bell-10: boulder substrate and banks thorough structure.</i>	<i>Photo 7. Bell-10: Beaver dam and wetlands at structure inlet.</i>

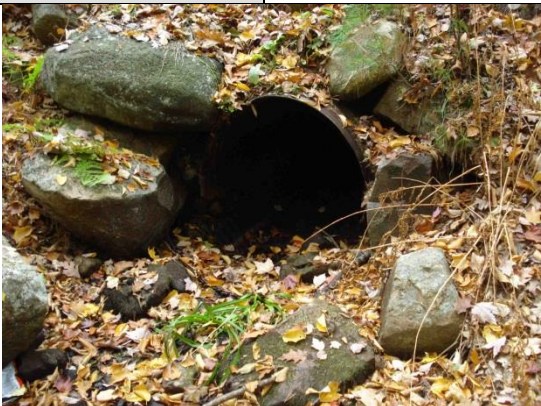
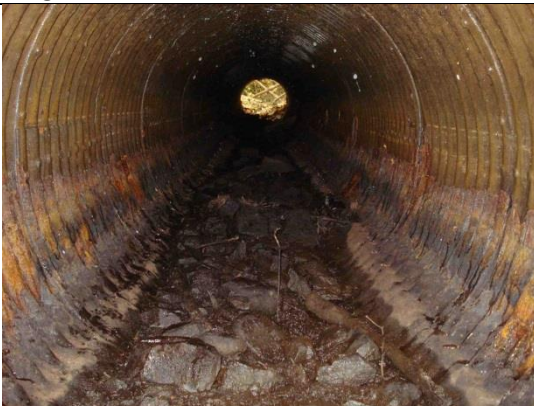
Photo 66. Scit-3: Inlet.	Photo 67. Scit-3: Sand and rocks deposited in culvert create a natural substrate pathway.
