Wildlife Monitoring at Road Crossings in the Western Maine Mountains Final Report - March 2016

**Barbara Charry, Maine Audubon Conservation Biologist/GIS Manager
Emily Bastian, Maine Audubon Project Coordinator**

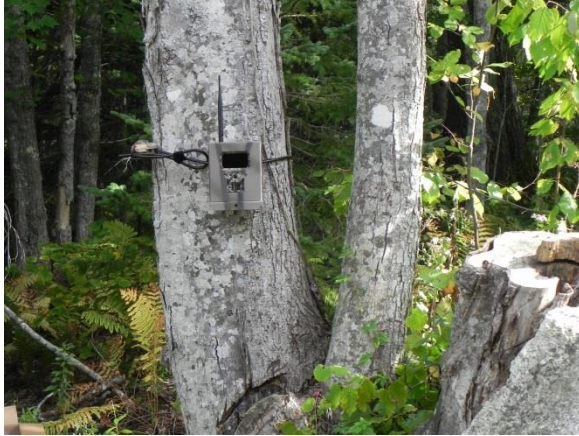
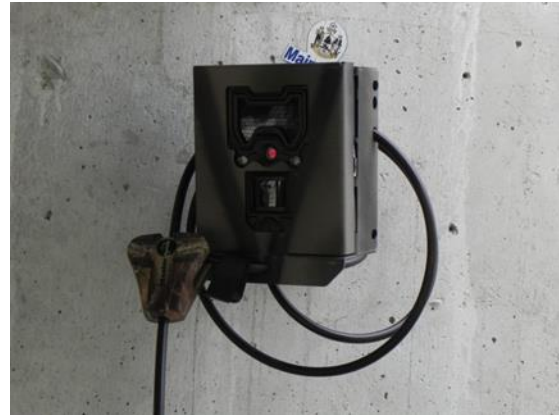
Mounting cameras on trees and bridge abutments

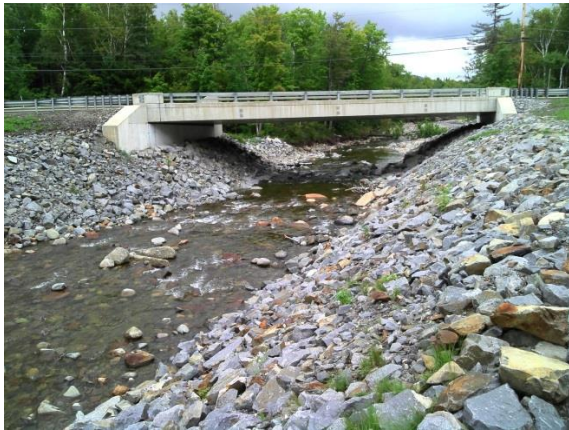
All structure types had wildlife moving through them (Table 3). One bridge had the greatest number of wildlife trips and the Carrabassett 8 Bridge had no recorded wildlife trips. This bridge has very steep heavily riprapped banks and no vegetative cover for thousands of feet on either side of the structure.

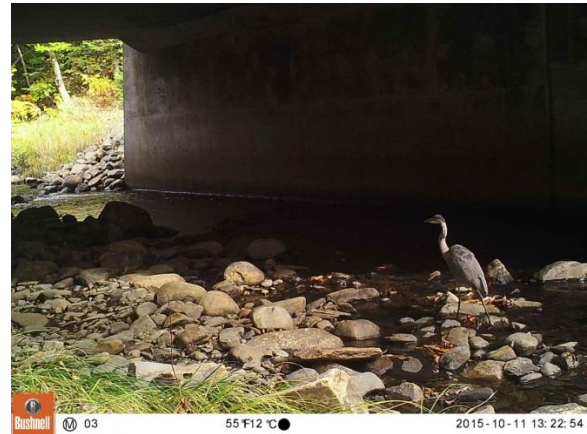
Great-Blue Heron in Sandy 2 Bridge

The plastic and concrete pipe culverts and concrete box culvert had similar numbers of wildlife trips. Raccoons used all structure types. Ermine mostly used the concrete pipe but was also recorded using the plastic pipe. Mink were only found using bridges and concrete box culverts. Deer were only recorded walking through shallow water under bridges. Great-blue herons were frequently recorded flying through and using habitat under bridges for foraging. (Tables 4 & 5)
