Flood Effects on Road–Stream Crossing Infrastructure: Economic and Ecological Benefits of Stream Simulation Designs

ABSTRACT: Stream simulation design is a geomorphic, engineering, and ecologically based approach to designing road–stream crossings that creates a natural and dynamic channel through the crossing structure similar in dimensions and characteristics to the adjacent natural channel, allowing for unimpeded passage of aquatic organisms, debris, and water during various flow conditions, including floods. A retrospective case

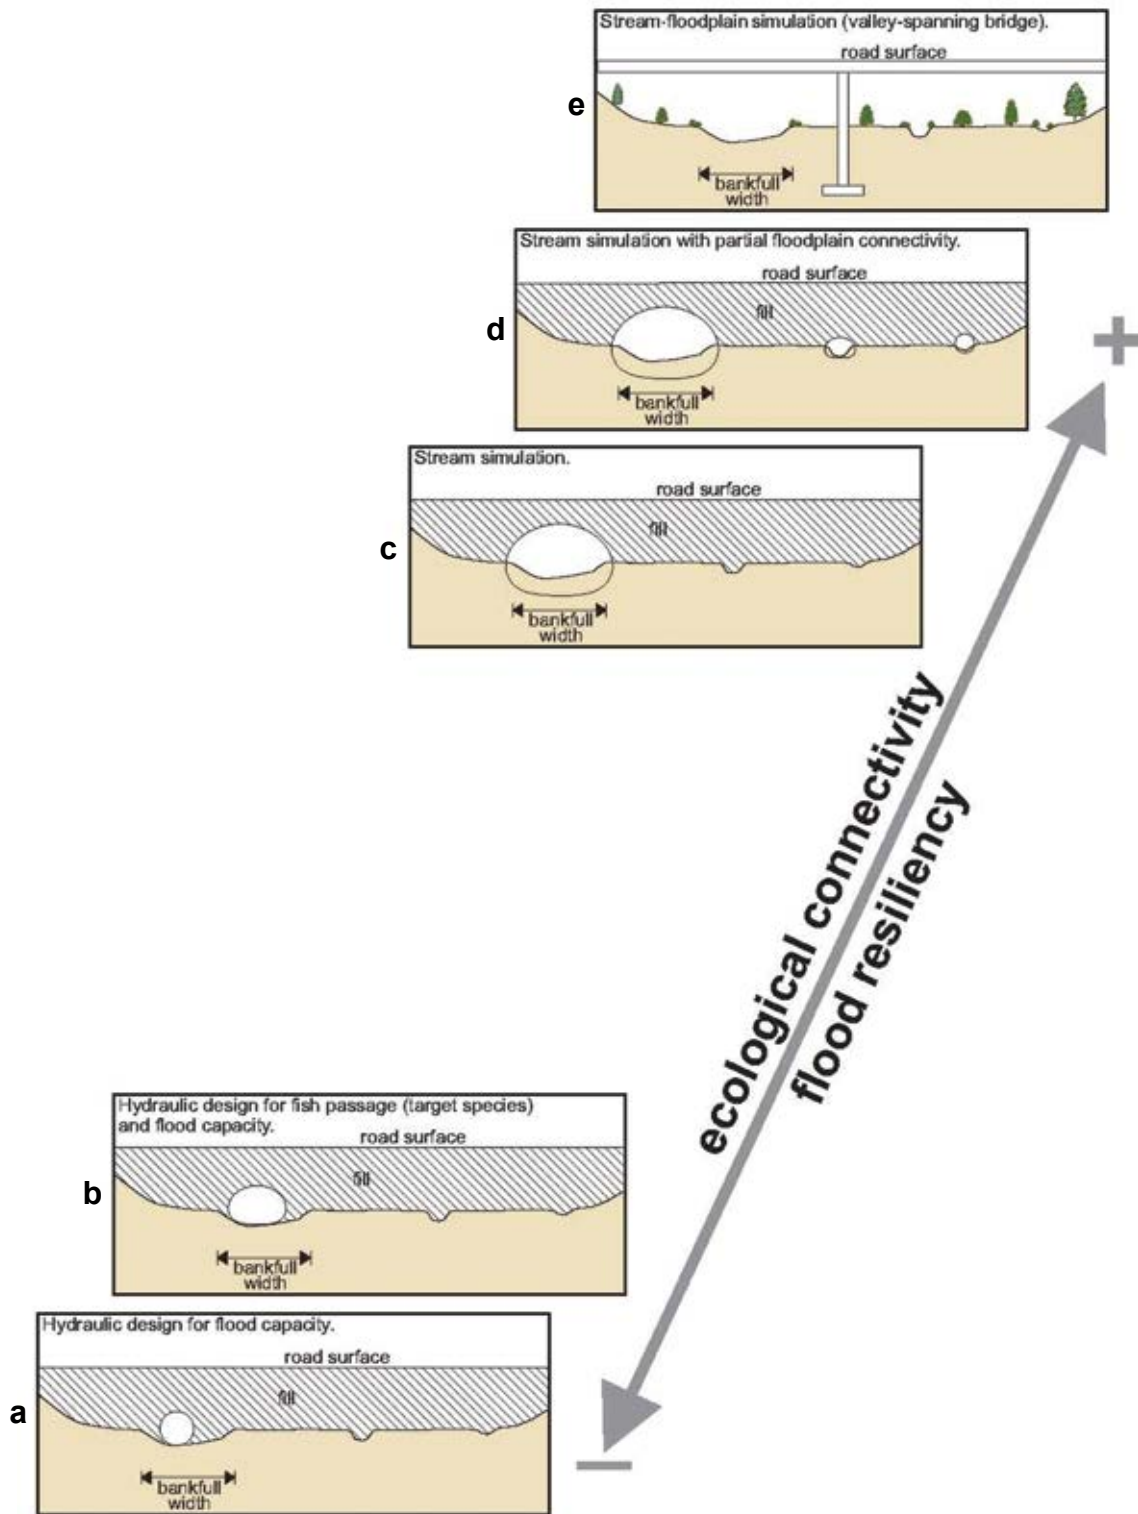
Figure 2. An ecological connectivity and flood resilience continuum for different design approaches at road-stream crossings (adapted from SSWG, 2008). The stream-floodplain simulation design (top graphic) provides passage for all aquatic and terrestrial species all at flow levels and minimal interference of stream and floodplain processes, resulting in greater ecological connectivity and flood resiliency. The stream simulation design (middle graphic) provides for fully functioning floodplain processes, passing floodwater, sediment and woody debris and all aquatic species for a broad range of flows. The hydraulic design for flood capacity (bottom graphic) only provides for partial functioning of stream processes, impedes passage of some floodwaters, sediment, and woody debris during high flows, and impedes passage of most aquatic species for most flows, consequently providing low ecological connectivity and flood resiliency.

and Washington (Orsborn et al. 2002; Clarkin et al. 2005). Prior to the 1970s, a hydraulic design approach to road–stream crossings focused on efficiently conveying flood flows with minimal or no concern for the movement and habitat needs of fish (Figure 2a). In the 1970s and 1980s, hydraulic design structures were modified to create hydraulic conditions that allowed for passage of adult fish including fishways, baffles, and weirs (Figure 2b; Cenderelli et al. 2011). Structures substantially narrower than the width of the adjacent natural channel, however, were only partially successful in allowing passage for the targeted adult fish species, and they did not address the passage needs of multiple species occupying the stream corridor at different life stages and flow conditions. Into the 1990s, hydraulic engineers continued to study and provide design advice to agency fisheries biologists. As Endangered Species Act listings for Pacific Coast salmonids increased in the 1990s and understanding of river and stream geomorphology among agency staff improved, inventories of road system crossings and design improvements to provide passage of all aquatic species, not just adult salmon and trout, increased. Recognizing the limitations of hydraulic design approaches for meeting the passage needs of multiple species occupying the stream corridor at different life stages and flow conditions, a stream simulation design approach was developed (Figures 2c–2e).

Long-term maintenance and replacement costs should also be considered. Hydraulic designs (Figures 2a and 3) that constrict the stream channel can incur a yearly maintenance cost from debris removal and pose a greater risk of unexpected replacement costs from failure during large magnitude floods (Furniss et al. 1997). In contrast, stream simulation designs that span the bankfull channel (Figures 2c–2e and 4) have demonstrated minimal or no annual maintenance costs and are flood resilient and are likely to last longer than their projected service life (Long 2010). Galvanized steel culverts installed using the stream simulation design method have an anticipated service life of 50 to 75 years because the constructed stream channel

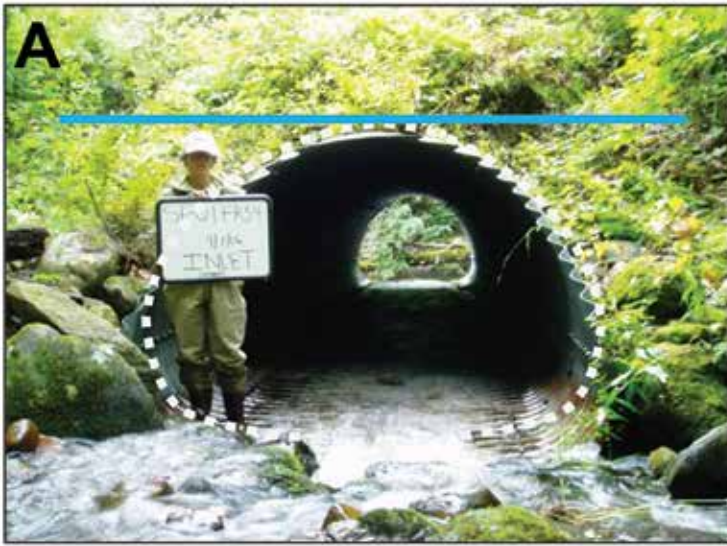
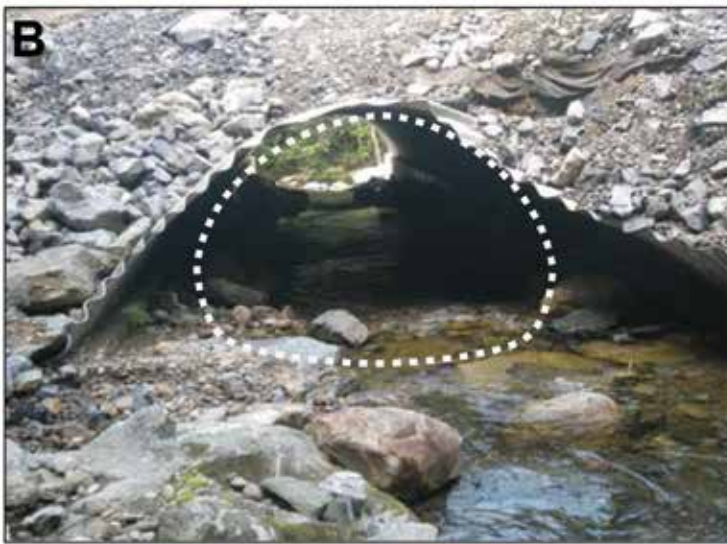
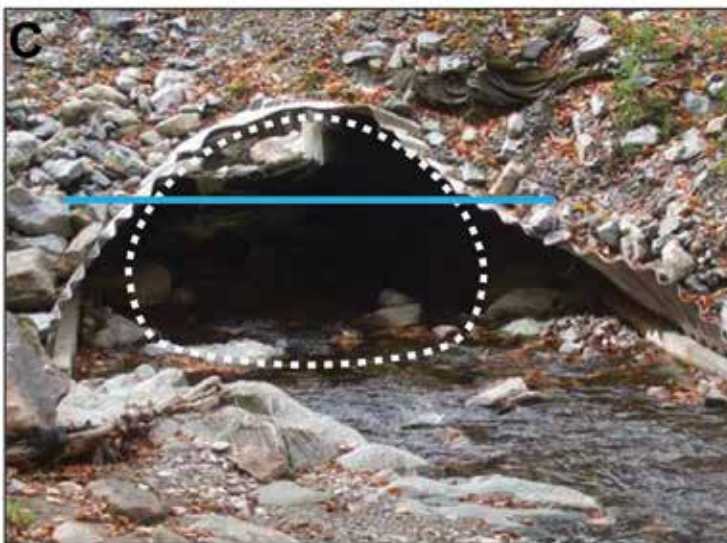
Figure 3. Sparks Brook road-stream crossing located on the Green Mountain National Forest, showing (a) original hydraulic design pipe-arch built in late 1960's, with a 2.5 m span and 1.9 m rise; (b) stream simulation design open-bottom arch structure built in 2010 with 4.5 m span, 1.62 m rise and footers extending 2.7 m below channel bed; (c) replacement structure after Irene flood. The blue line illustrates the actual peak flood water-surface elevation as well as the estimated peak flood elevation if the original culvert had been in place. Photo credit: Dan McKinley, Green Mountain National Forest.

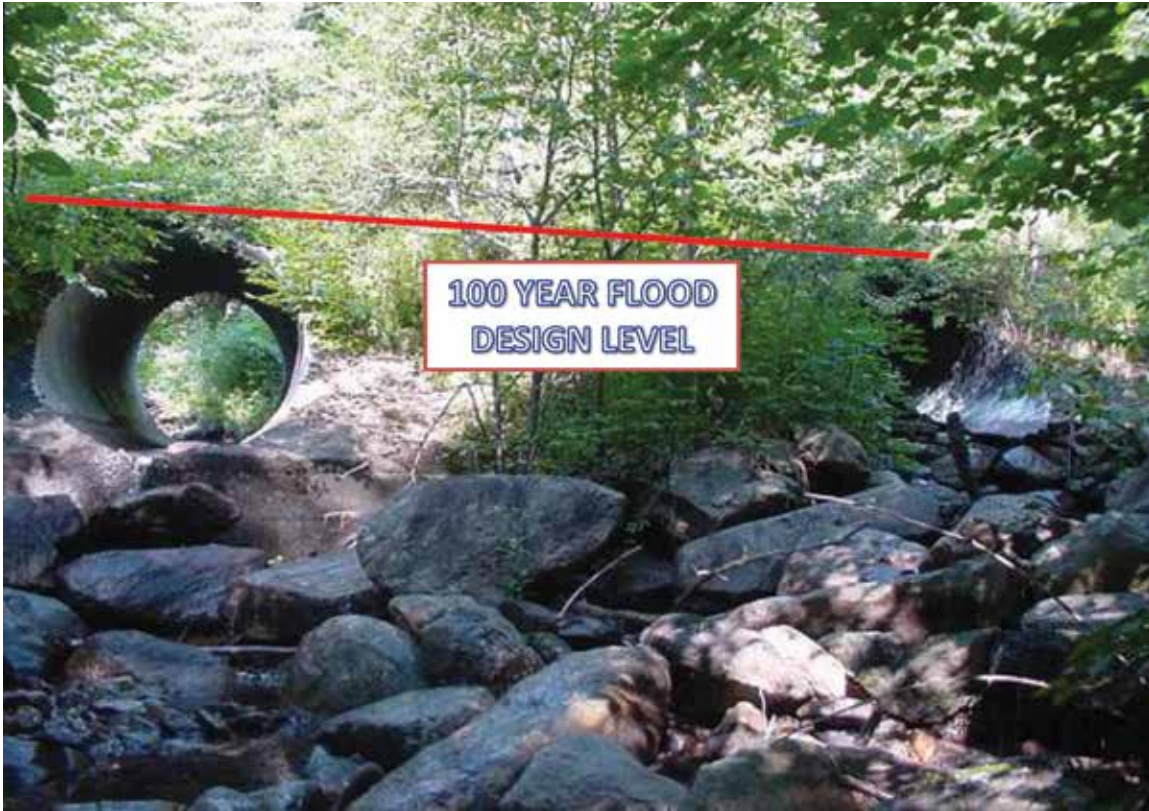
Figure 4. Typical hydraulic design double culvert over Jenny Coolidge Brook, May 2010. Green Mountain National Forest showing estimated height of 100-flood design discharge in red. Photo credit: Brian Austin, Green Mountain National Forest.

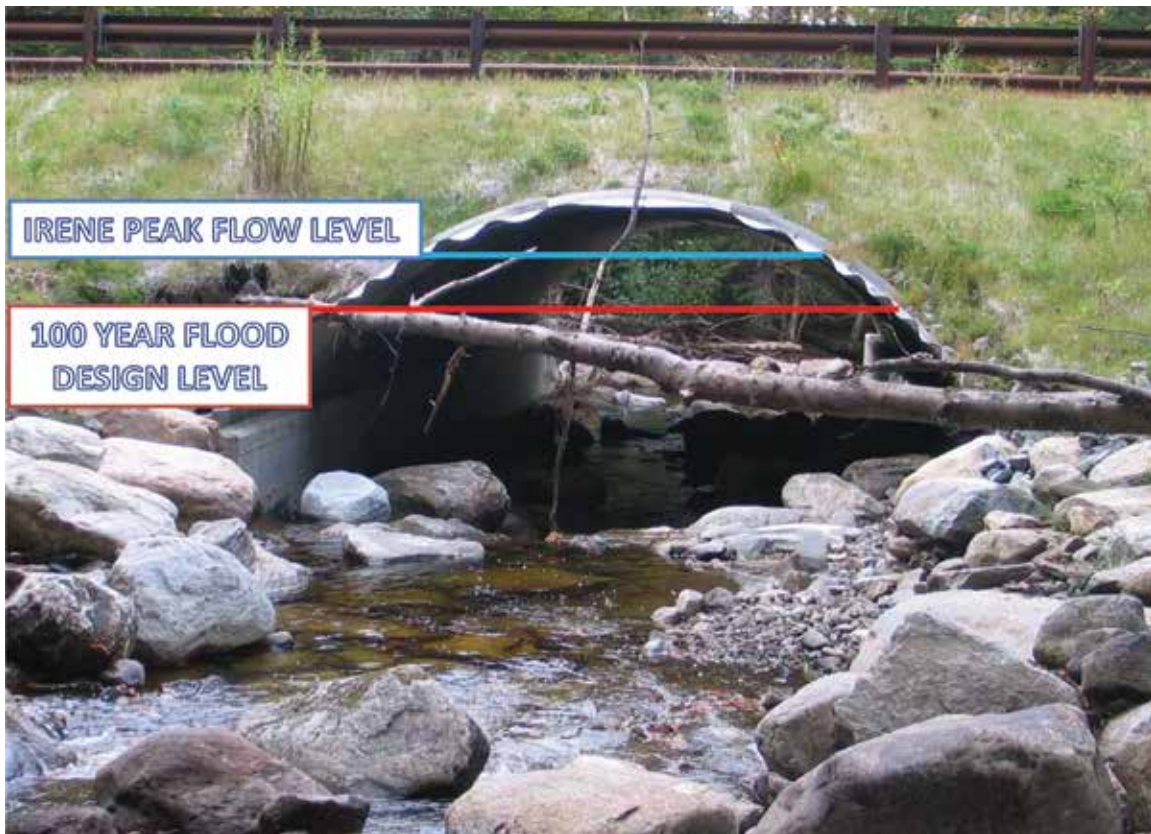
Figure 5. Stream simulation design culvert at Jenny Coolidge Brook, installed in June 2010, showing height of 100-year design discharge in red and height of Tropical Storm Irene flood level in blue. Photo credit: Brian Austin, Green Mountain National Forest.

The hydraulic capacity design method differs from the stream simulation design method in fundamental ways (Figure 5). Stream simulation design determines the size of the structure based on the physical dimensions of the natural channel first and foremost and evaluates hydraulic capacity as a secondary check to ensure sufficient conveyance of the 100-year flood with additional clearance for debris transport. In contrast, traditional hydraulic design methods give no consideration of the actual physical dimensions of the natural channel when sizing the road–stream crossing structure. Hydraulic design structures are sized to pass a design flood (e.g., Q10 flood, Q25 flood, Q100 flood) with headwater-to-depth ratios typically at 1.0 or greater (Hotchkiss and Frei 2007). Design flood discharge estimates are usually determined using regional regression equations that typically have standard error estimates greater than 40%. Additionally, regional regression equations used to predict design discharge were typically developed for larger drainages and are not necessarily applicable to small drainages, which add to the uncertainty of the discharge estimates. Recent analyses and predictions under a changing climate suggest that the set of return interval floods underlying hydraulic capacity designs are no longer valid. In New England, trends in measures of precipitation intensity (Huntington et al. 2009) and frequency of larger precipitation events increased by 85% since 1948 (Madsen and Wilcox 2012), and the recent record-breaking storm events such as Tropical Storms Irene, Lee, and Sandy (Douglas and Fairbank 2011) and the projected increases in total annual precipitation (Intergovernmental Panel on Climate Change 2007) and rain on snow events (Douglas and Fairbank 2011) strongly suggest the need for changing flood discharge estimates.
