**Maine Terrestrial Wildlife Crossings Survey Report:**  
***Potential for Retrofitting Transportation Infrastructure to  
Benefit Movement of Terrestrial Wildlife***

**July 2015**

**In Collaboration with:**  
**Maine Department of Transportation, Richard Bostwick**  
**Maine Inland Fisheries & Wildlife, Derek Yorks**  
**The Nature Conservancy, Dan Coker**

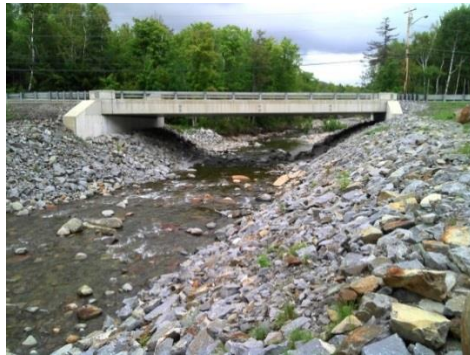
- Lack of stream banks through the culvert to provide a dry pathway;
- Extensive riprap around structure entrances and along stream banks, which can inhibit wildlife from entering into or traveling through the structure.

Extensive riprap on Route 27,  
Carrabassett Valley © Maine Audubon

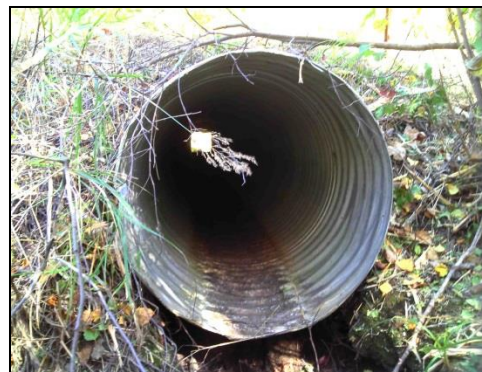
Perched outlets can prevent animals, particularly small fauna, including salamanders and turtles, from entering into a culvert that may otherwise provide passage for these species. Some perched culverts can be retrofit by creating a graded slope or ramp leading from the culvert outlet.

Perched outlet at location Mount-4 on Mountain Road. © Maine Audubon

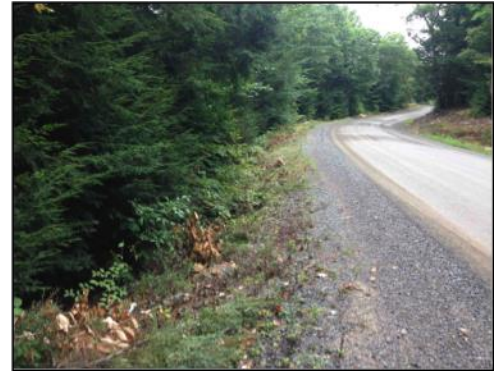
Photo 1. Typical road profile on Bell Marsh Road

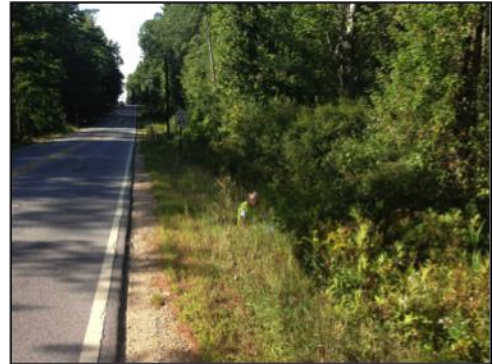
Photo 65. Typical road profile on Scituate Road
